Town of Edson Sanitary Sewer Condition Assessment

August 15, 2023
Council Resolution #171 - 2023

Submitted to: Town of Edson
Prepared by McElhanney

Our file: 3231-10590-00

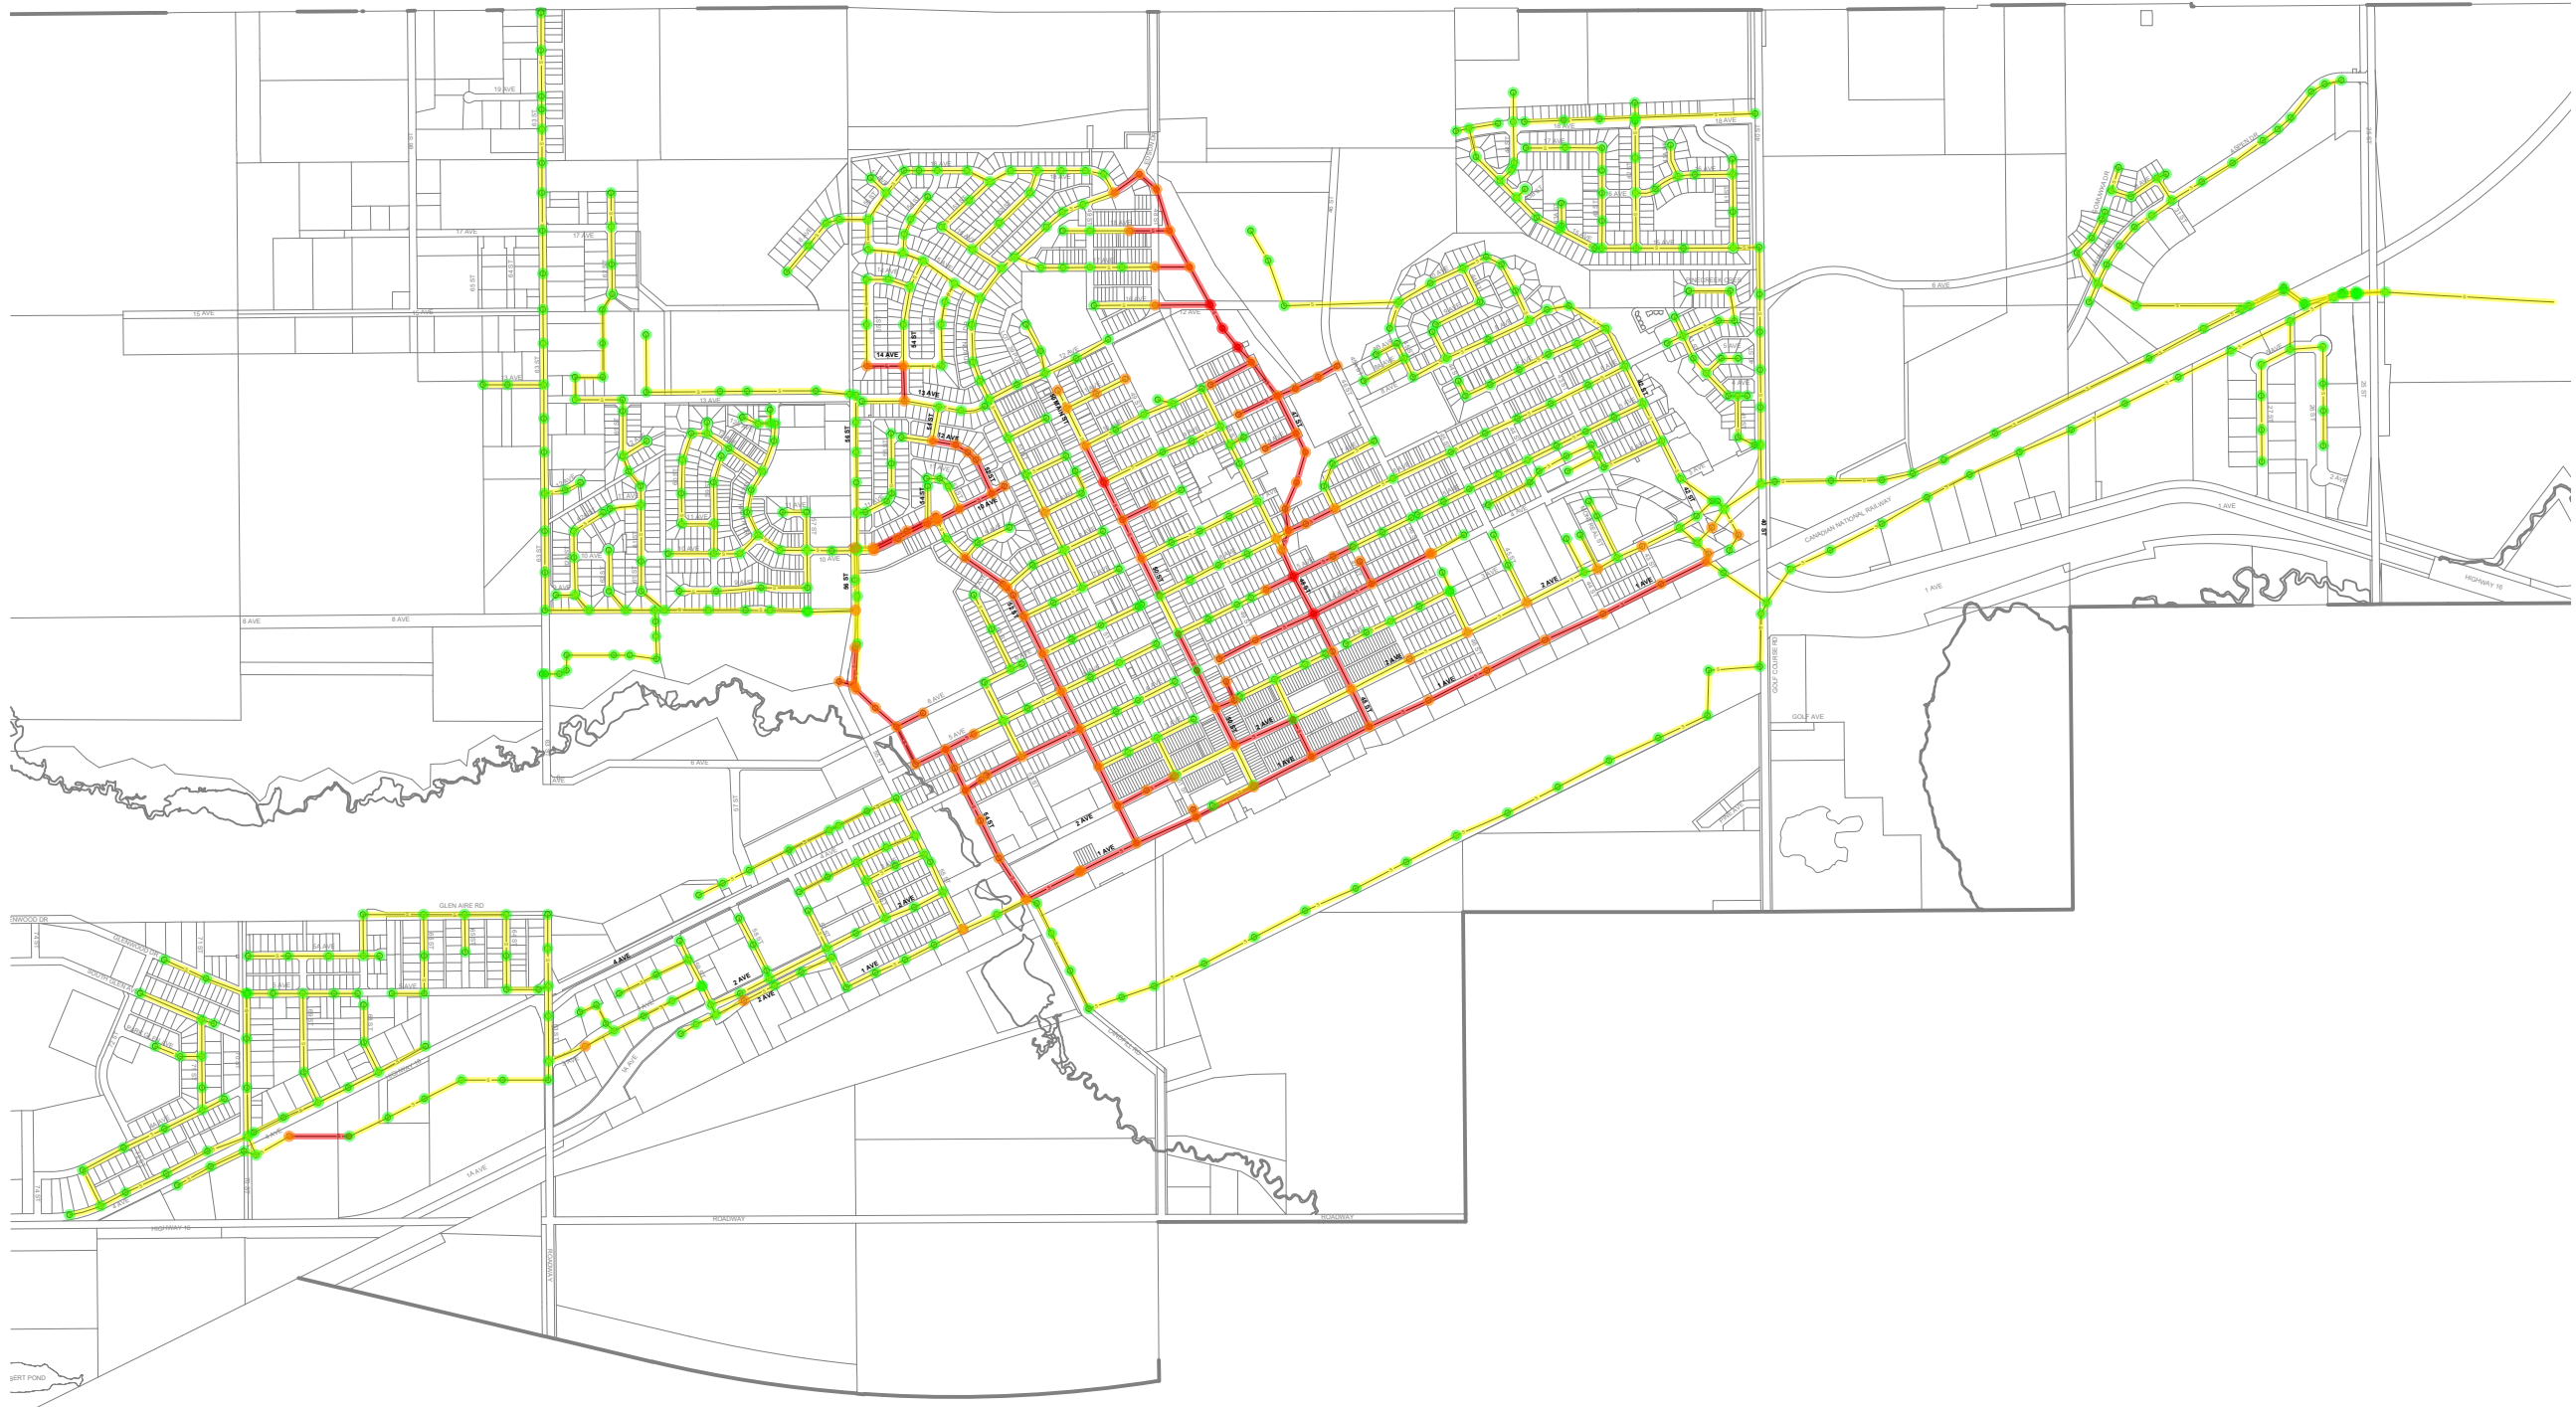
DATE: July 25, 2023, 1:40 PM FILE: X:\3231\Projects\3231-10590-00 Sanitary Sewer Condition Assessment\10.0 DRAWINGS\10.3 Engineering\10.3.2 Sketches\01 - Sanitary Figures (for Report)\3231-10590-00-FIG14-PWWF-CAPACITY.dwg

The colour classification used in depicts the maximum depth of flow in the pipe (d) as a percentage of the diameter of the pipe (D). Design criteria related to pipe flow has been discussed in **Section 2**; for this analysis pipe full greater than 80% is considered deficient. The modeling completed indicates several deficiencies in the ability of the existing gravity system to convey the design PDWF and PWWF, with several specific areas of concern. **Figure 14: PWWF Capacity Assessment Existing Population** shows pipe not meeting this design criteria.

The existing 375mm / 450 mm diameter sewer trunk along 1st Avenue is shown as surcharged. This is attributed to a combination of the high base groundwater inflow from the northwest residential subdivision, high RDII inflow from the north central subdivision, and flat pipe slopes. This was discussed in the Major Storm Summary & Sanitary Overflow Technical Memorandum (McElhanney, 2022). Model results indicated surface flooding of 97 m³ at MH S358 on 6th Avenue, between 55th Street and 53rd Street, due to surcharged conditions. This was supported by reports of flooding by Town operations staff.

The existing 250 mm diameter sewer trunk along 52nd Street is shown as surcharged. This is significant as this sanitary trunk services a large residential area, with associated high inflow and infiltration.

The existing 200 mm diameter sewer main along 50th Street is shown as surcharged. Similar to Area of Concern #3, this sanitary main services a large residential area, with associated high inflow and infiltration.
