Environmental Assessment

Tributary to Bench Creek - Lions Park Bridge Removal (SE-22-53-17- W5M)

Prepared for:
Town of Edson

October 2022

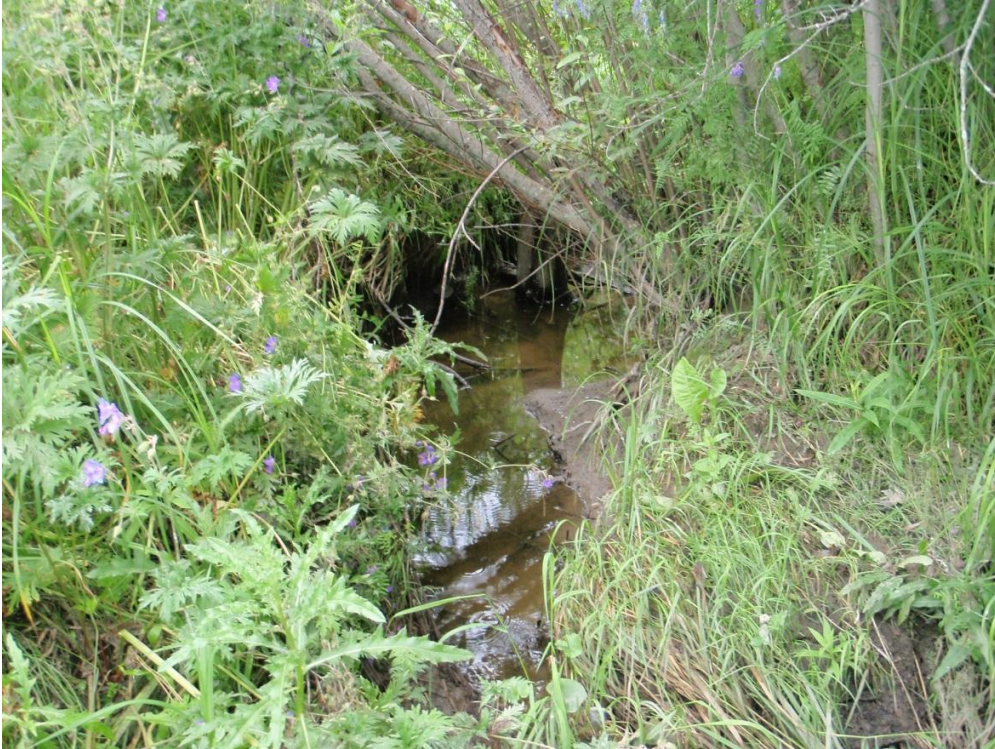
Photograph 1. Approximately 40 m upstream of the bridge crossing, looking upstream.

Upstream of the bridge removal location (Photographs 1 and 2), the channel was confined and took on an irregular meandering morphology. The channel was generally well defined and stage of flow at the time of assessment was low. Mean wetted width and water depth were 0.36 m (range: 0.24 – 0.57 m) and 0.05 m (range: 0.03 – 0.09 m). The mean bankfull width was 0.53 m (range: 0.28 – 0.70 m) and the mean bankfull depth was 0.41 m (range: 0.38 – 0.42 m). Within the section of channel upstream of the bridge location, habitat consisted predominantly of Class 3 runs. The substrate was primarily composed of fine materials, with partially embedded gravel present in several sections. Instream cover consisted of abundant overhanging vegetation (primarily grasses), moderate amounts of undercut banks, and trace instream vegetation. Riparian vegetation was composed of abundant grasses, in addition to occasional shrubs and trees. The banks were generally vertical and composed of fine materials.

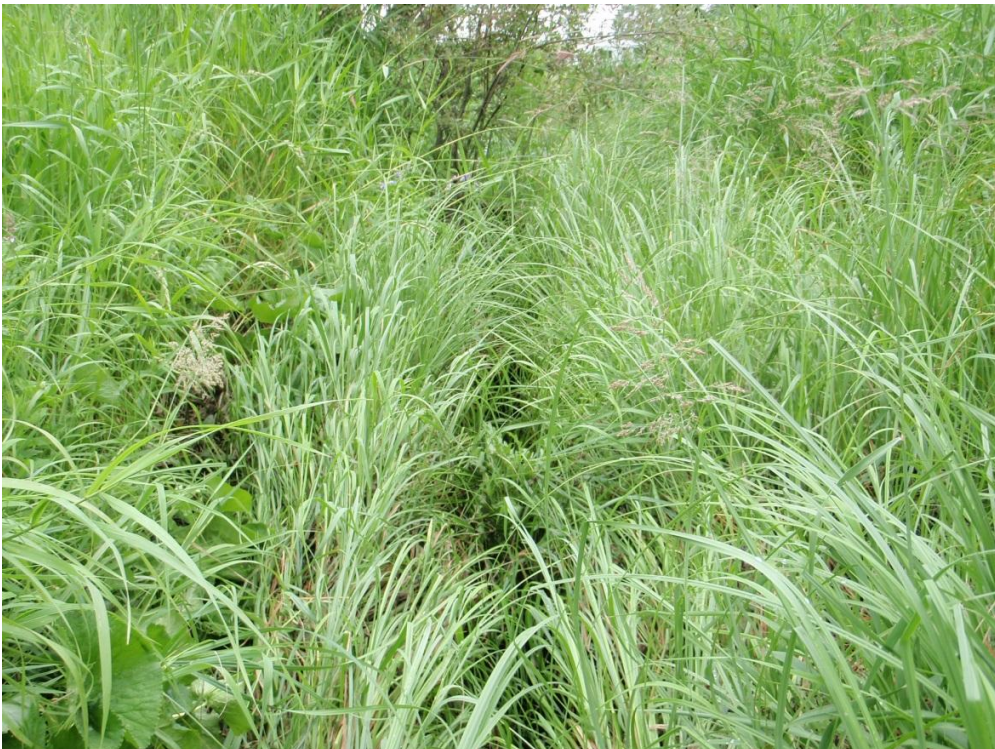
Photograph 2. Approximately 20 m upstream of the bridge crossing, looking downstream.

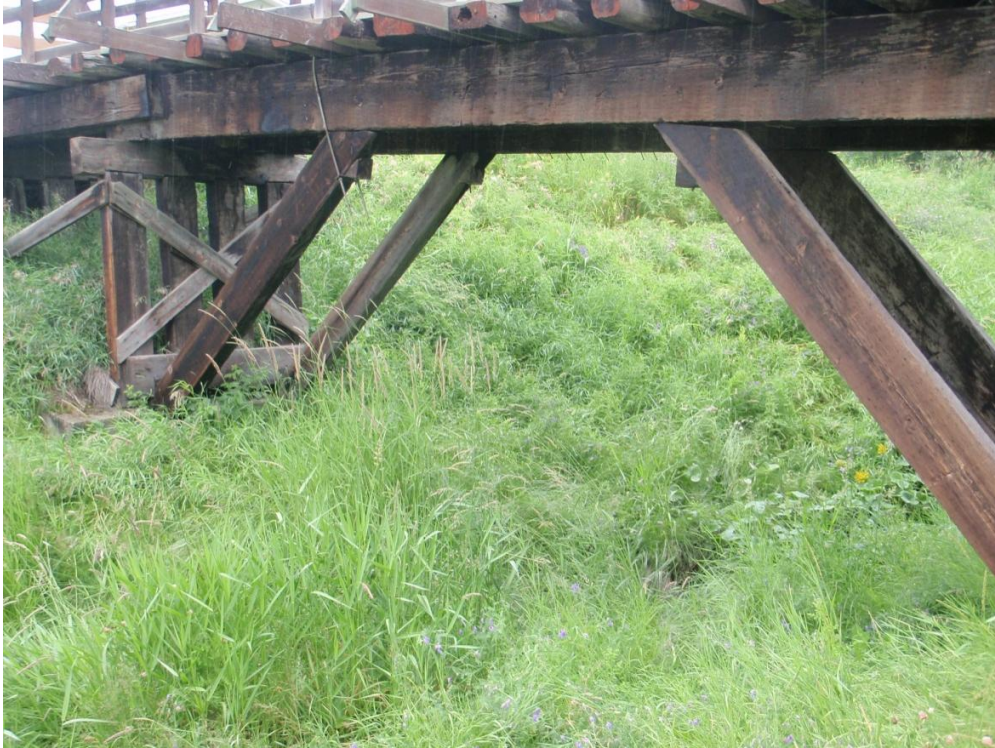
Photograph 3. Downstream side of bridge crossing, looking upstream.

The existing bridge at the crossing location (Photograph 3) was a 3 span timber pedestrian bridge approximately 15 m in length. Channel and wetted width below the bridge were 0.51 m and 0.49 m, respectively. Channel and water depth were 0.42 m and 0.19 m, respectively. Habitat type below the bridge was a Class 3 (<0.5 m depth) flat. Dominant substrates were fines, with a moderate amount of embedded cobble. Fish cover consisted of moderate-abundant overhanging vegetation and trace amounts of instream vegetation. Riparian vegetation was primarily composed of grasses.

Water quality parameters measured at the existing bridge location included pH (7.49), conductivity (697 µS/cm), water temperature (16.0 °C) and dissolved oxygen (4.0 mg/L, 45% saturation). Water quality measurements were within the tolerance range low dissolved oxygen tolerant species (e.g. brook stickleback or fathead minnow) common in the region (Newbury and Gaboury 1993; Scott and Crossman 1998).

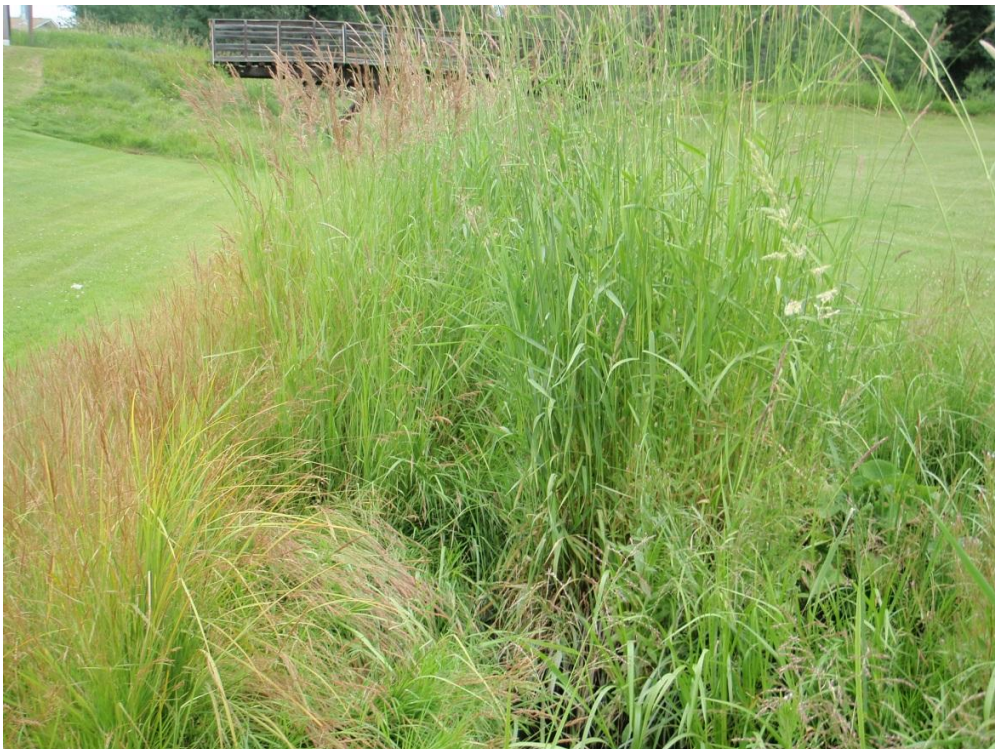
Photograph 4. Approximately 40 m downstream of the bridge crossing, looking upstream.

Downstream of the bridge removal location (Photographs 4 to 6), the channel remained confined, with a low degree of sinuosity. Approximately 80 m downstream of the pedestrian bridge, the stream flows through a 1700 mm culvert of approximately 67 m in length that runs under a roadway (2nd Avenue, Edson). The watercourse then flows southeast through a forested area before entering an underground tunnel for approximately 460 m until its confluence with Bench Creek.

Similar to upstream, the channel was generally well defined. The channel and wetted width averaged 1.06 m (range: 0.51 – 0.89 m) and 0.84 m (range: 0.49 – 0.70 m), respectively. Mean channel depth was 0.35 m (range: 0.16 – 0.42 m). Mean water depth was 0.14 m (range: 0.06 – 0.19 m). Habitat consisted primarily of Class 3 flats and runs with occasional small sections of riffles. Substrates were composed of moderate-abundant fine materials with moderate amounts of cobble and trace gravel and boulders. Fish cover from the crossing to approximately 60 m downstream consisted of abundant overhanging grasses (80%). Further downstream, fish cover was abundant, consisting of overhanging grasses, shrubs and trees, small and large woody debris, and boulders. Similar to upstream, the banks were generally vertical and composed of fine materials.

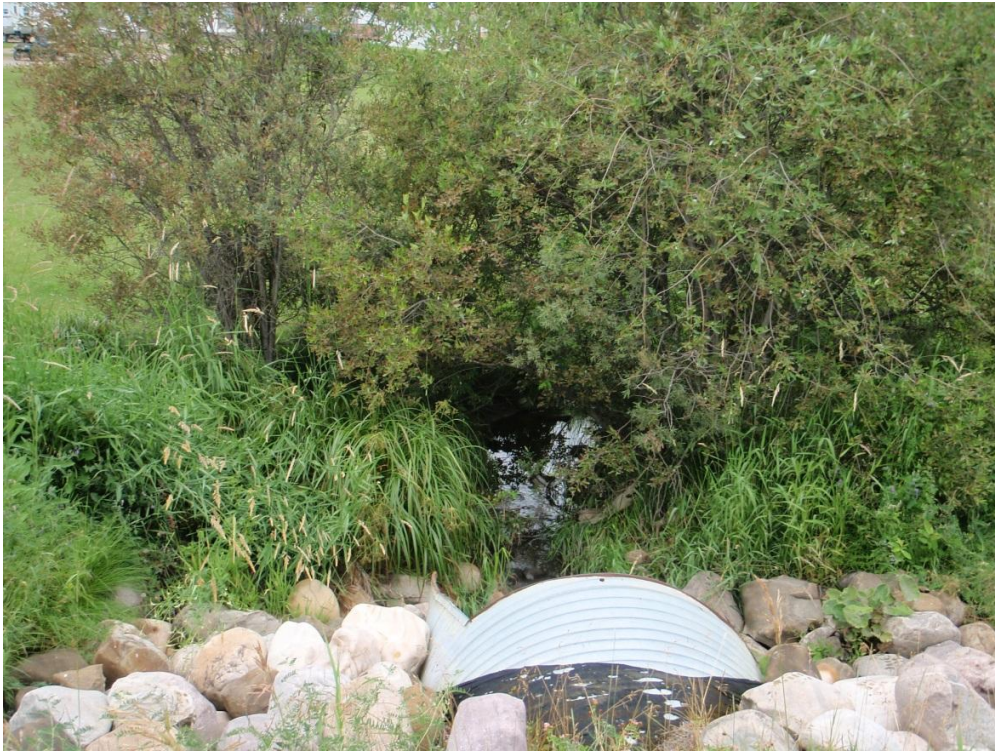
Photograph 5. Approximately 80 m downstream of the bridge crossing, looking upstream.

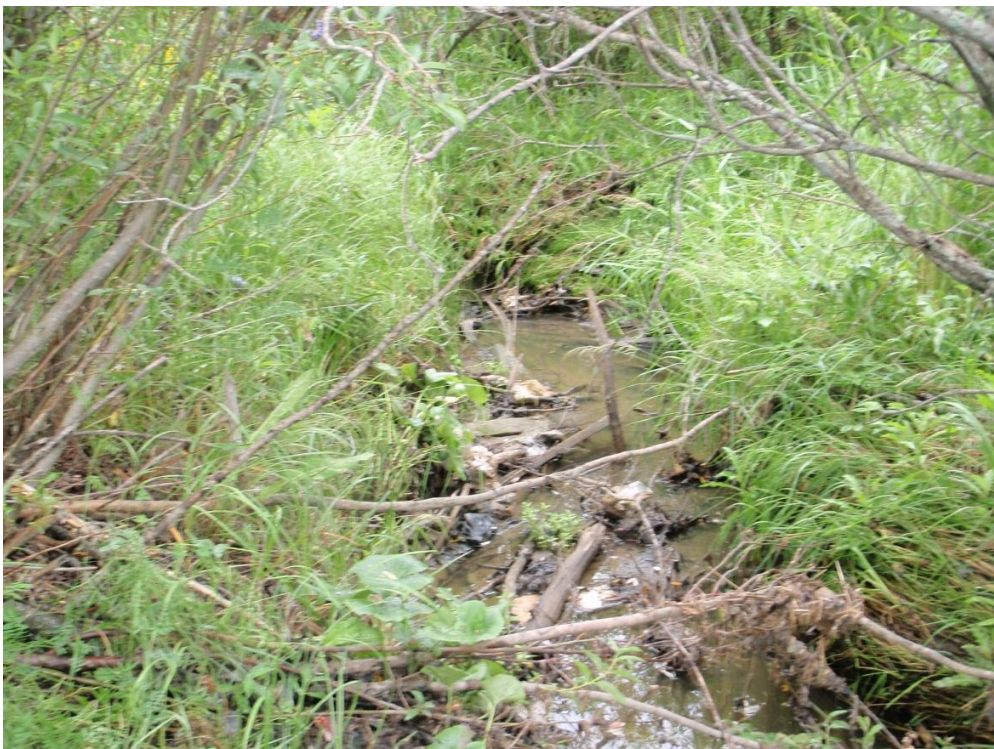
Photograph 6. Approximately 170 m downstream of the bridge crossing, looking downstream.
