Town of Edson Sanitary Sewer Condition Assessment

August 15, 2023
Council Resolution #171 - 2023

Submitted to: Town of Edson
Prepared by McElhanney

Our file: 3231-10590-00

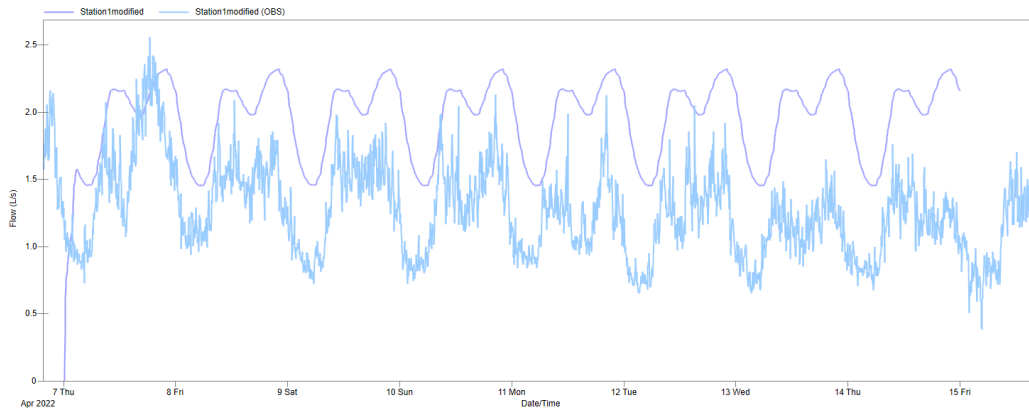
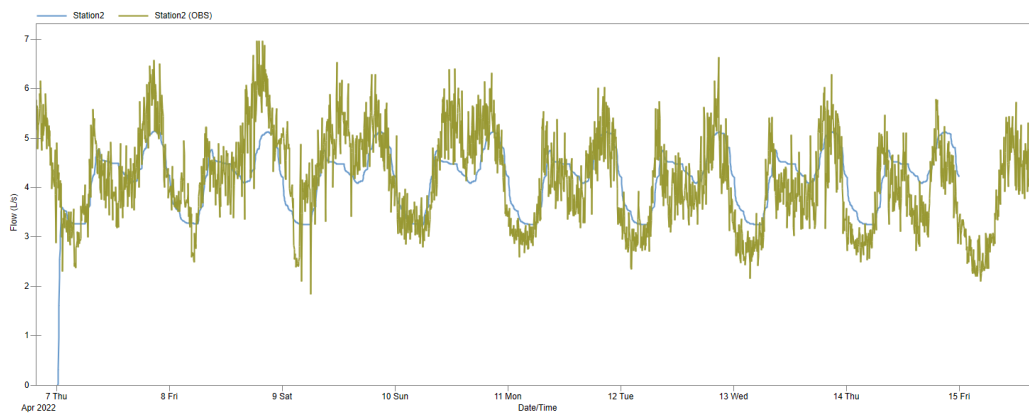
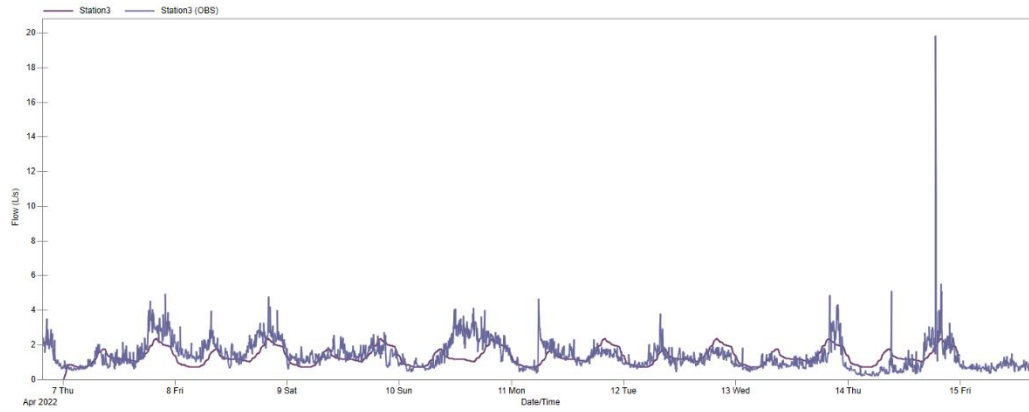
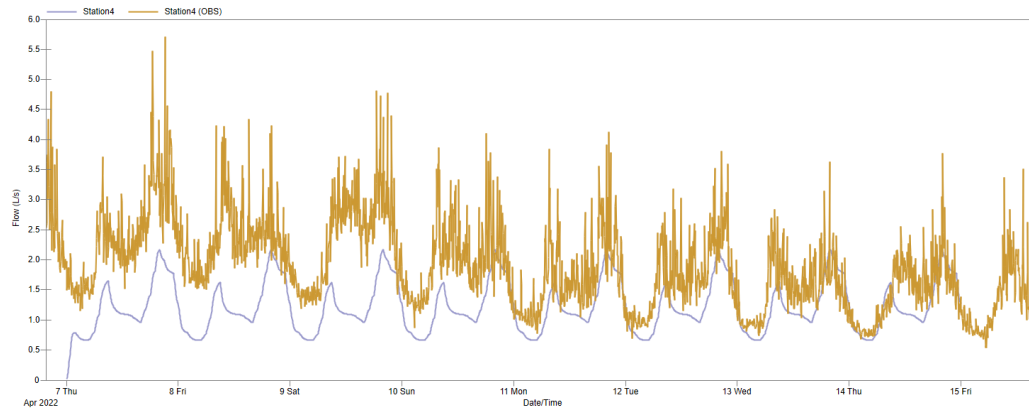
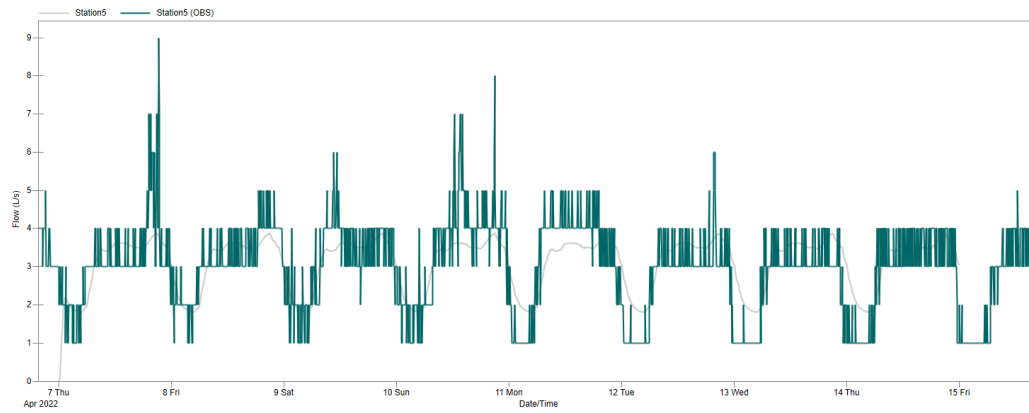
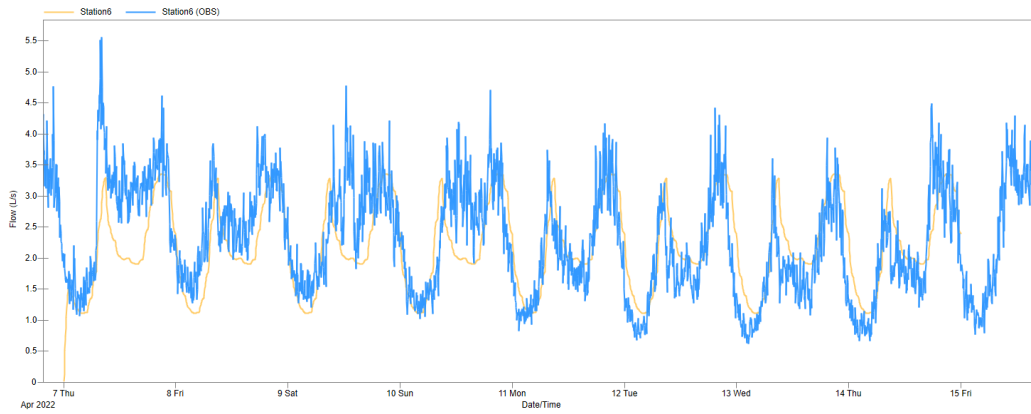
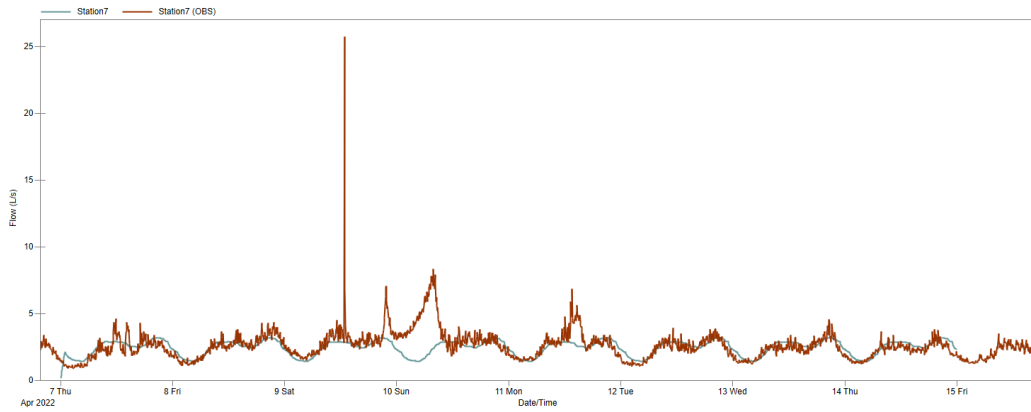
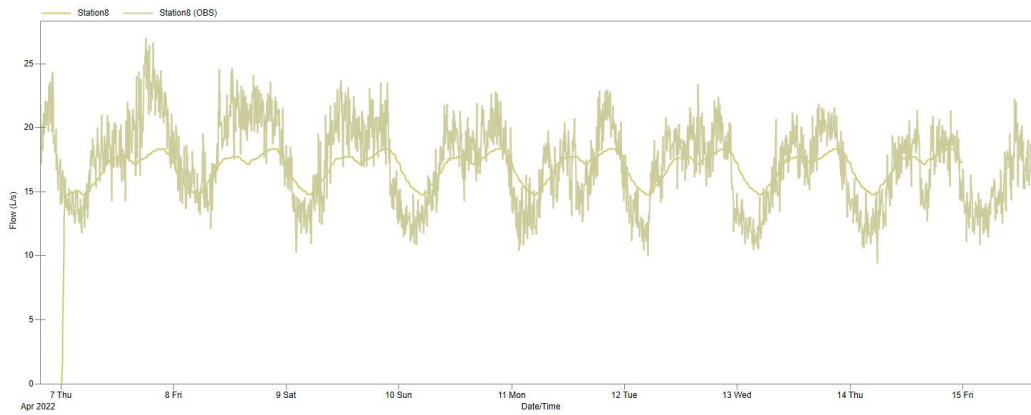
Figure 5: PDWF Model Verification

Table 6 and **Figure 5: PDWF Model Verification** shows the modeled and monitored PDWF values and the percent differences during the analysed dry period. For estimation of PDWF, a percent difference less than 10% is typically targeted. As shown, an average percent difference of 10.1% has been achieved for the analyzed dry period.

Per **Section 3.5**, and flow data per **Figure 5: PDWF Model Verification**, a very significant contribution to the total sanitary inflow is the SW Commercial Area from 63rd Street to 70th Street. Given that 17.5% of the Town sanitary inflow is attributable to this single source of I/I, this is the highest priority deficiency for investigation. The cause is currently unknown, however, given the proximity to Bench Creek it is possible there is a direct source of inflow. An investigation should be performed, with the following scope:

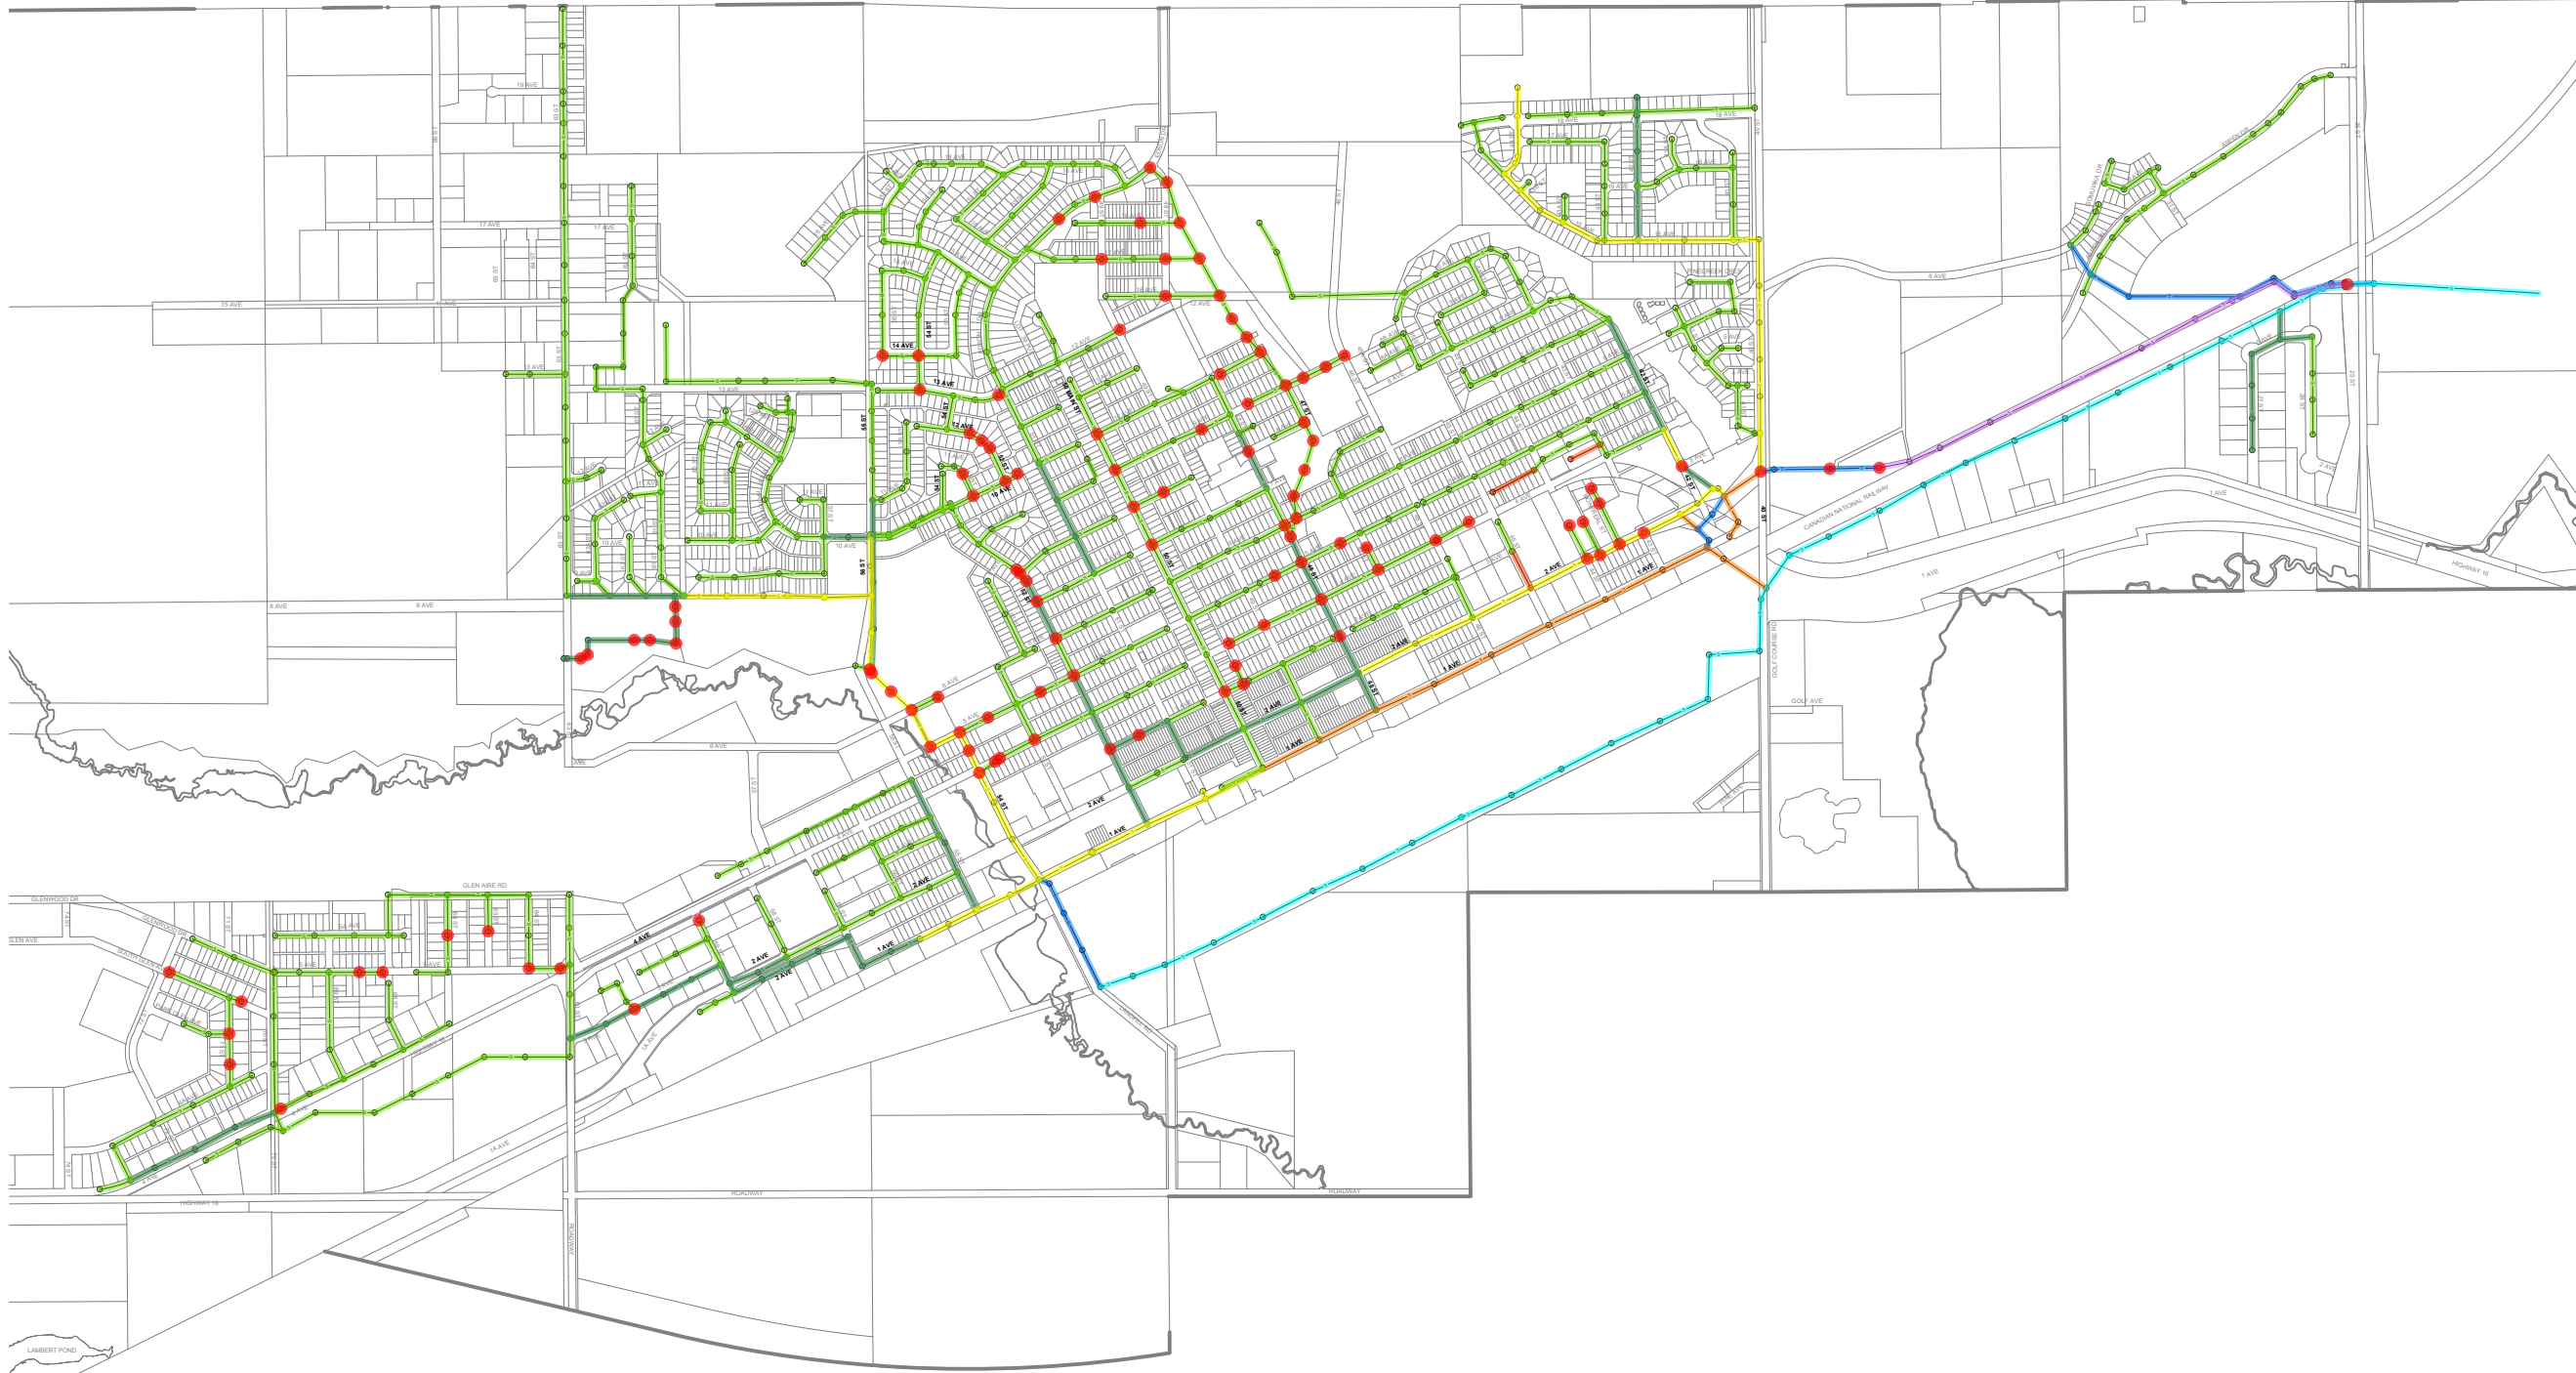
The colour classification used in depicts the maximum depth of flow in the pipe (d) as a percentage of the diameter of the pipe (D). Design criteria related to pipe flow has been discussed in **Section 2**; for this analysis pipe full greater than 80% is considered deficient. The modeling completed indicates several deficiencies in the ability of the existing gravity system to convey the design PDWF and PWWF, with several specific areas of concern. **Figure 14: PWWF Capacity Assessment Existing Population** shows pipe not meeting this design criteria.

The Town has reported sewer backup at several residences along the sanitary main from 10th Avenue continuing to 14th Avenue. This is supported by the computational modeling. This was covered in the 10th Avenue Flooding Technical Memorandum (McElhanney, 2022) where recommendations were made to complete the following.

The existing 375mm / 450 mm diameter sewer trunk along 1st Avenue is shown as surcharged. This is attributed to a combination of the high base groundwater inflow from the northwest residential subdivision, high RDII inflow from the north central subdivision, and flat pipe slopes. This was discussed in the Major Storm Summary & Sanitary Overflow Technical Memorandum (McElhanney, 2022). Model results indicated surface flooding of 97 m³ at MH S358 on 6th Avenue, between 55th Street and 53rd Street, due to surcharged conditions. This was supported by reports of flooding by Town operations staff.

The existing 250 mm diameter sewer trunk along 52nd Street is shown as surcharged. This is significant as this sanitary trunk services a large residential area, with associated high inflow and infiltration.

The existing 200 mm diameter sewer main along 50th Street is shown as surcharged. Similar to Area of Concern #3, this sanitary main services a large residential area, with associated high inflow and infiltration.

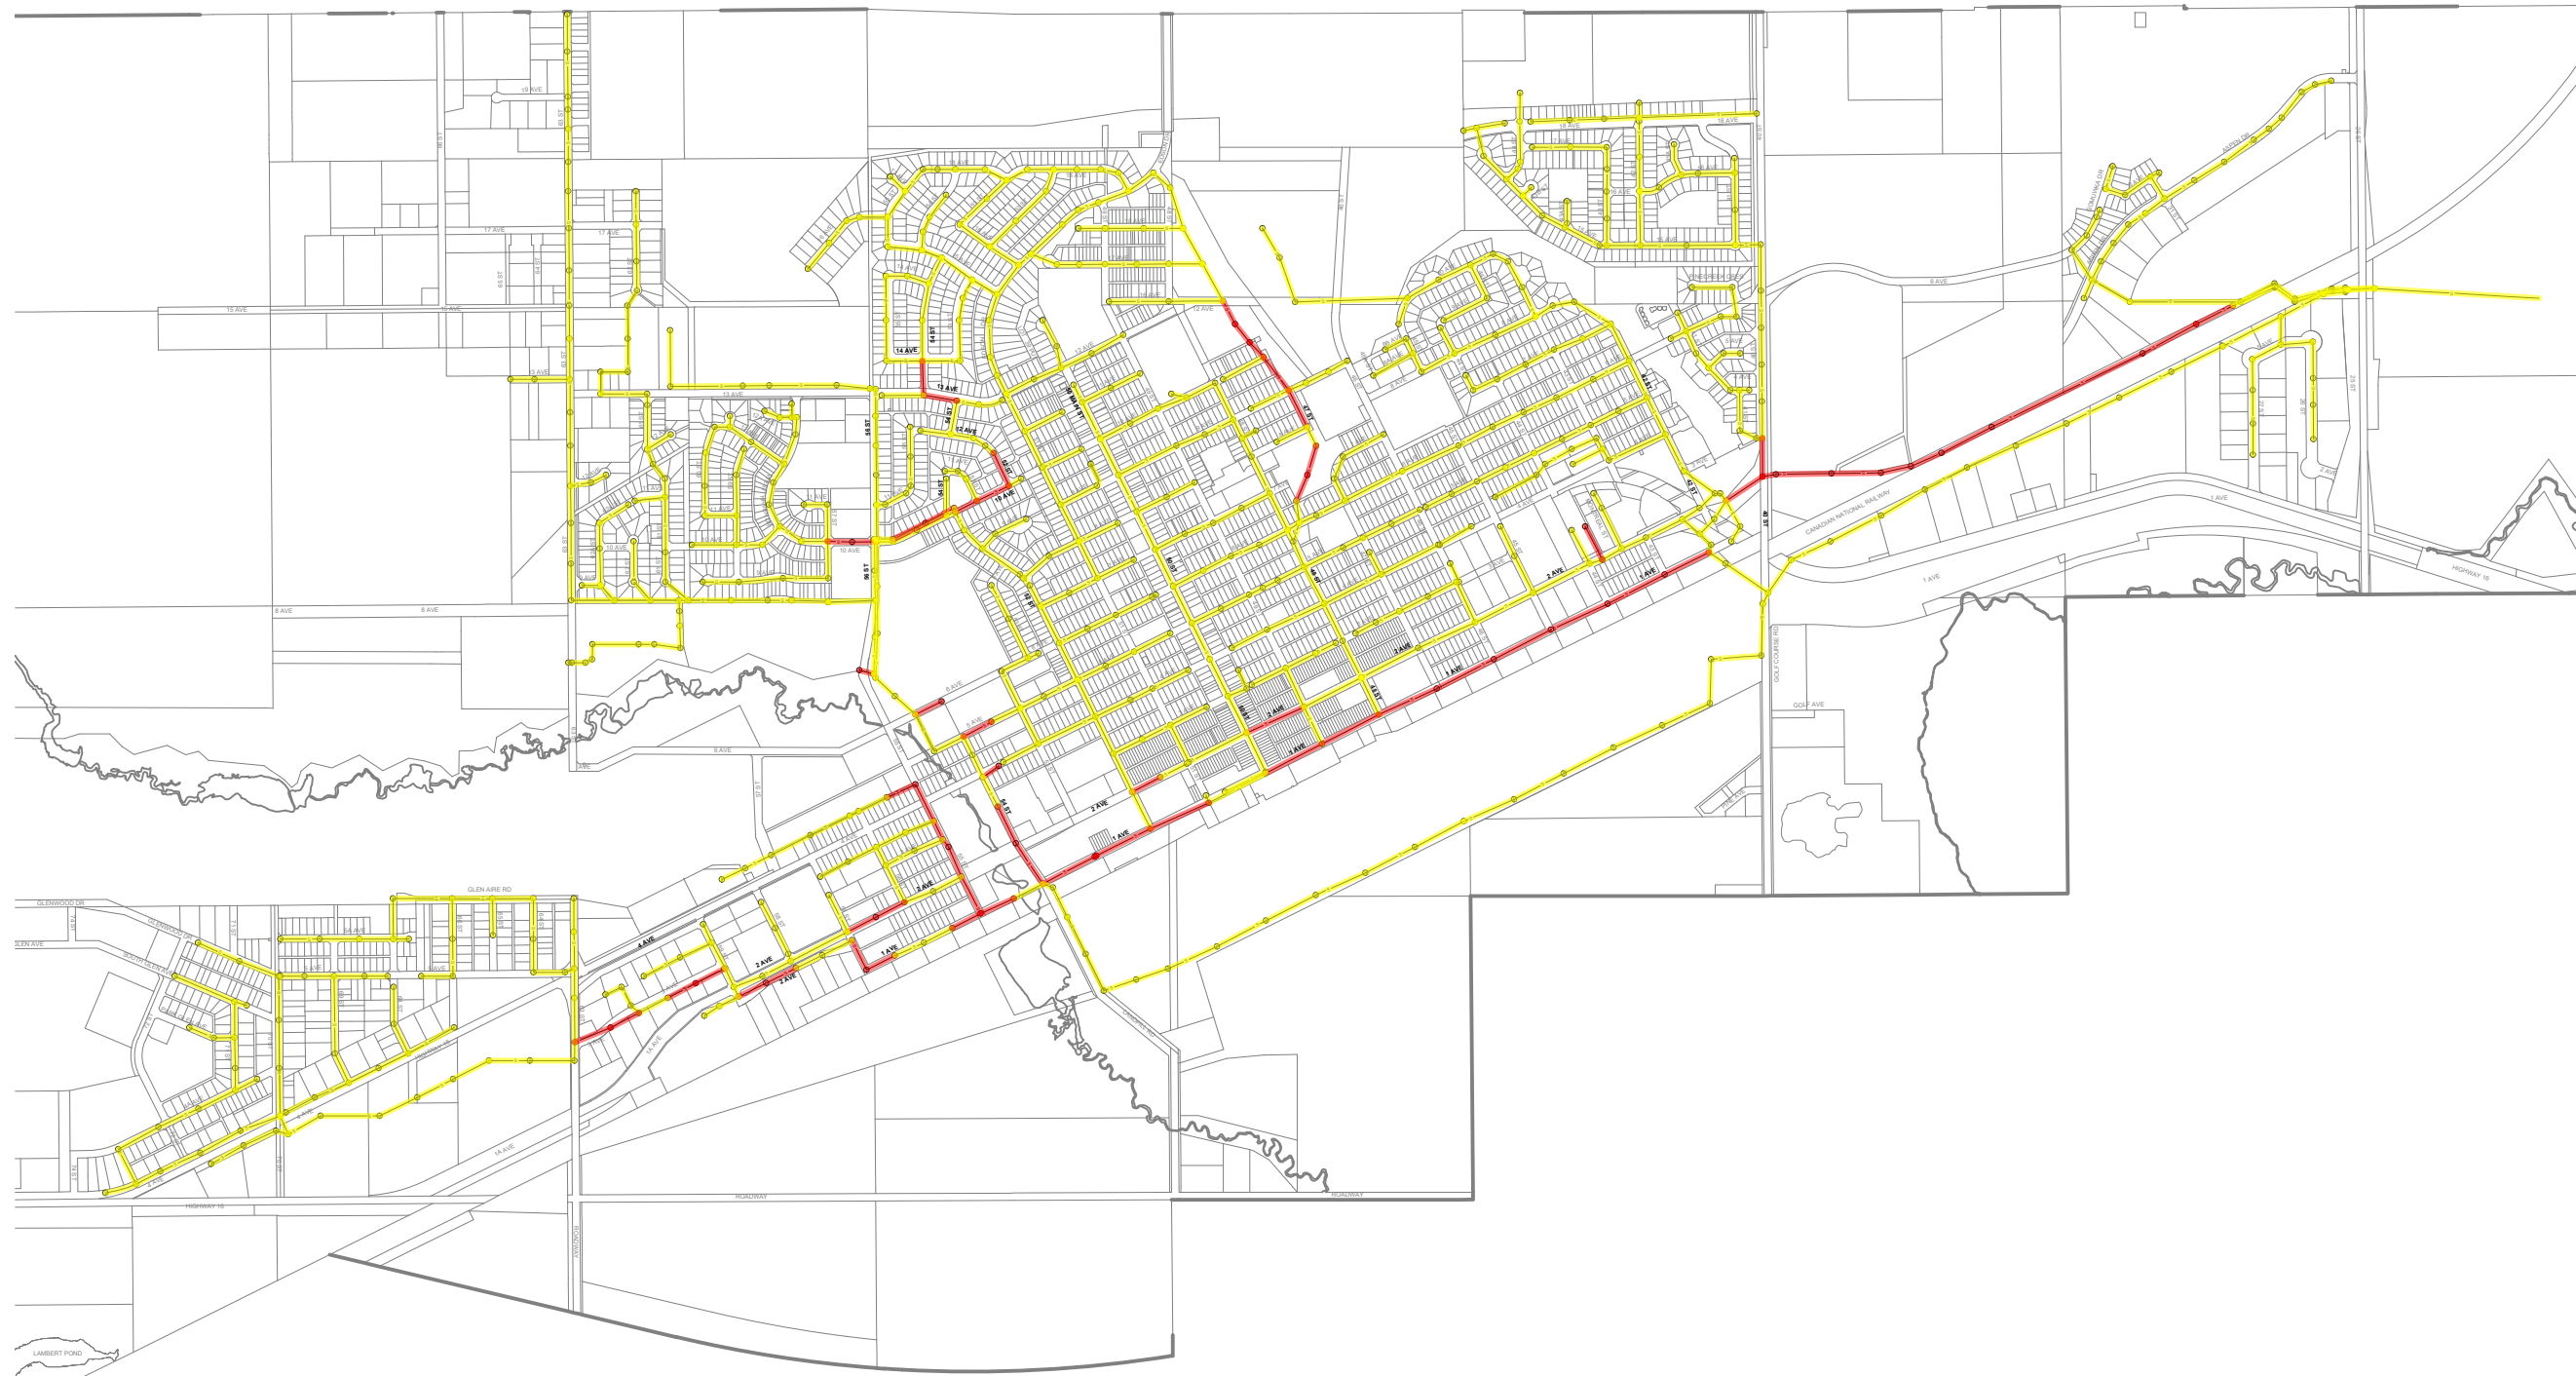
Additionally, problem areas can be delineated by reviewing areas where surcharged pipe is within 2.2m of surface; these areas are more likely to have flooded basements as the sanitary service is within the hydraulic grade line. These locations are identified in **Figure 15: PWWF HGL < 2.2m of Surface: Existing Population**.
